# UK Marine Case Studies

# Case Study 1 – 6.6kV Diesel-Driven Generator

# Case Study 2 – 690V Diesel-Driven Generator

## Case Study 3 – 690V Thruster Motor

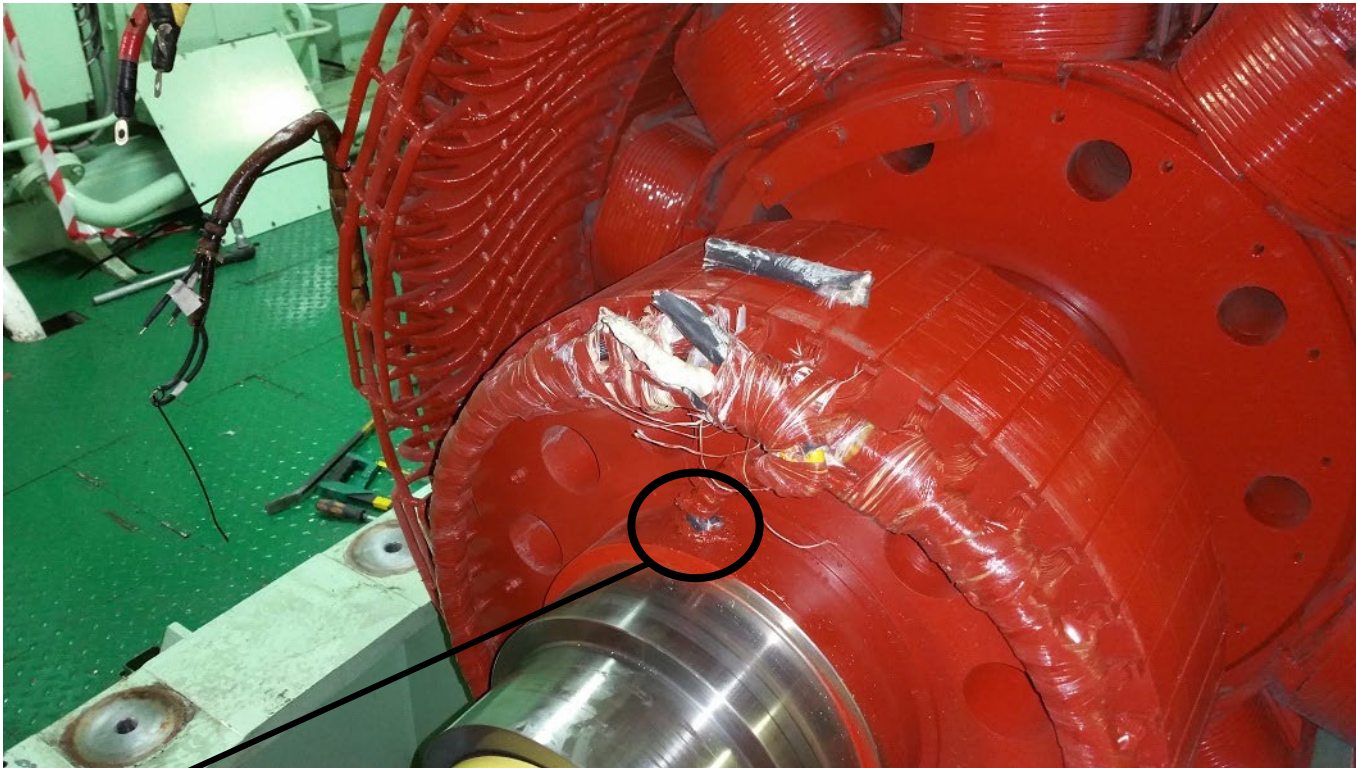
The 3 phase exciter rotor windings failed during the megohm test.

5 Phase cables chaffing on edge of hole,  
where cables pass through shaft

Customer asked his motor rewinder to verify our results, as he was on-board performing other work. He confirmed result, and decision was made to strip the machine there and then.

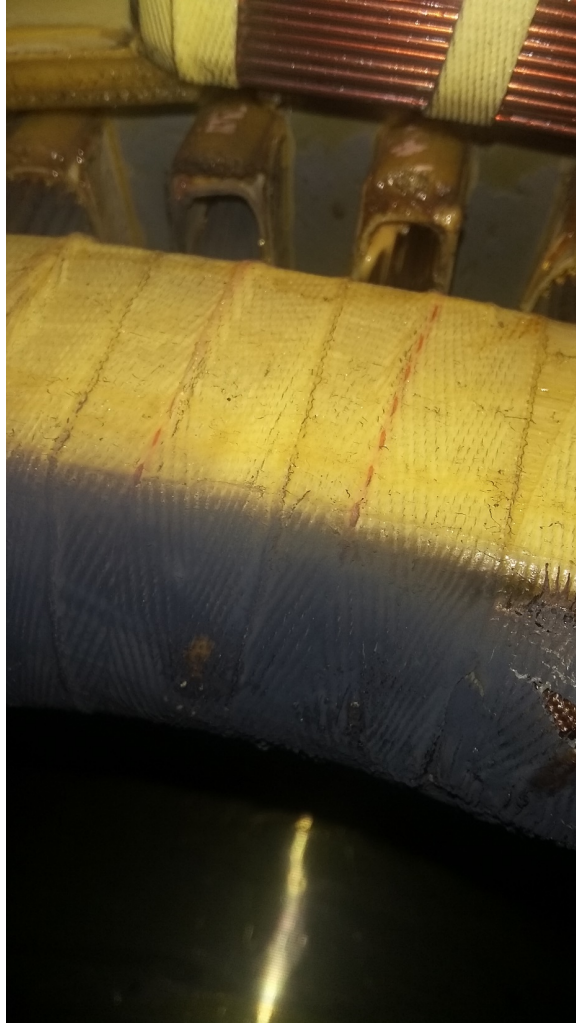
# Discolouration of Winding ?

- Most 3 phase windings are very balanced, typically 2% or less.
- 18% is a clear sign of a problem, but verify bad connections are not causing this.
- Customer did not believe results, as generator was running without any issues...
- Decided to use boroscope to see if there were any obvious signs of a problem

Boroscope inspection gave justification for further detailed inspection.

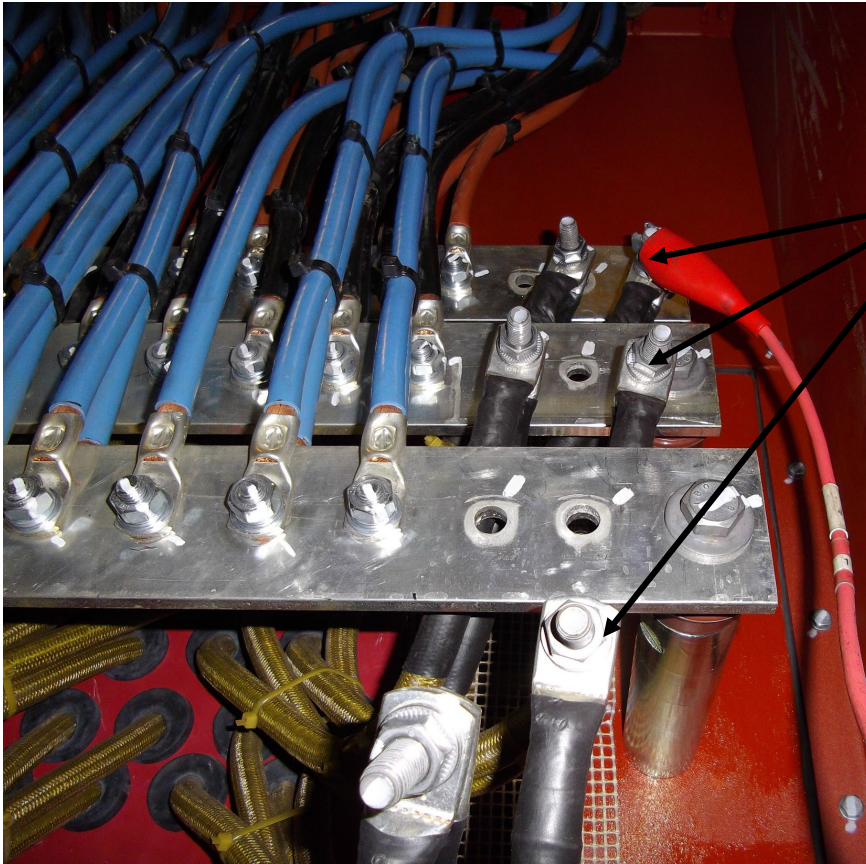
To test motor windings without the power cables in circuit

Winding leads removed from bus bars – much quicker than removing all the power leads !

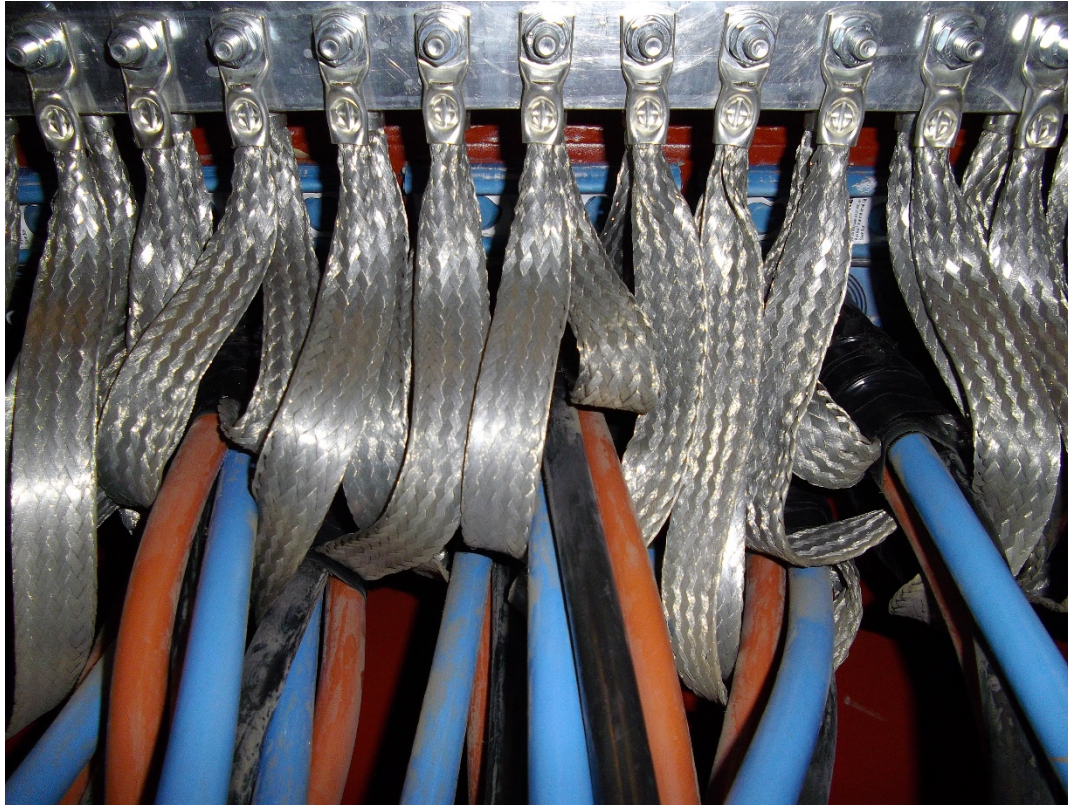
## Fault Located

IR of 7.6 GΩ @ 40° C, confirming that the motor is ok, and the likely cause of the low reading are the power cables.

Earthing straps were badly installed and caused chaffing to the cable insulation.

Customer claimed a warranty repair on the shipyard, as the vessel was only 18 months old.
