Network hub failure

Application Note

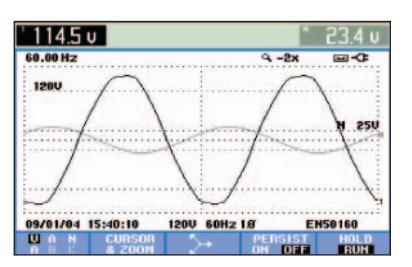
Fig. 2 High neutral waveform

After connecting his Fluke 434 to the branch circuit supplying the hub equipment, he checked the View Config screen (Fig. 1) diagram to verify proper connections. From there, he pushed the Scope button and saw an abnormally high neutral waveform. (Fig. 2) He checked the numeric values at the top of the screen and saw that neutral voltage was in fact incredibly high, at 23 volts, indicating a possible neutral-ground issue. He saved that screen for customer documentation.

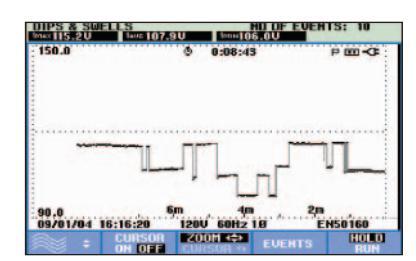
He pressed the Monitor button (Fig. 4) and set the recording time for 24 hours. After the first 15 minutes, he pushed the trend button while continuing to record in the background. (Fig. 5) Shortly into the cycle he saw a dip in the line. To learn more, he pushed the event table button, checked the numeric values, and saw distinct voltage sags on the branch circuit. (Fig. 6)

The panel was clearly carrying too much load, most likely from one or more of the facility's large motors. That meant the hub was seeing high voltage from the grounding problem and low voltage from the sags, both of which were causing the hub to go down.

Fig. 6 Dip swells

Due to the cost and time required to install a new receptacle on the branch circuit, the facility decided to add a UPS in front of the power supply to the hub. Since the remaining equipment on that line wasn't disrupted by the sags, no further actions were required. The consultant downloaded a report of the benchmark power quality measurements he'd made and gave it to the facility, who agreed to set up a regular preventive maintenance schedule.
