APPLICATION NOTE

CNA Insurance Saves Clients an Estimated \$13 Million Per Year in Energy and Repair Costs with Thermal Imaging Surveys

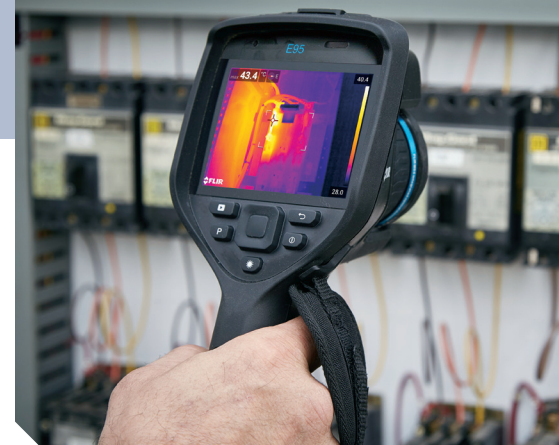
Figure 1. FLIR E95 Professional Thermal Camera

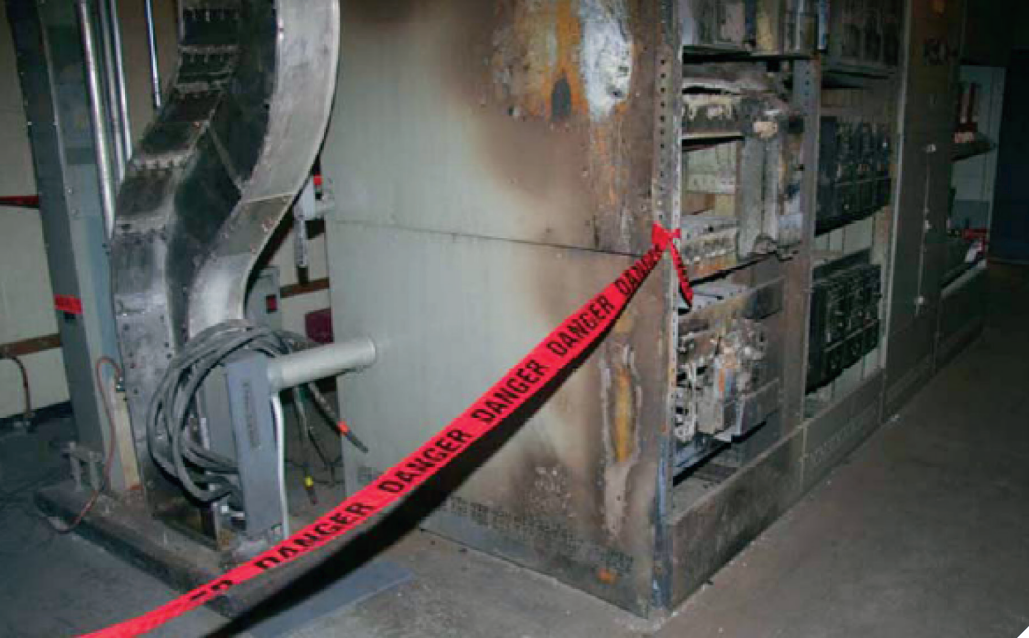
Figure 2. Switchgear fire that resulted in \$2.7 million in damage. This facility declined an IR survey offer by a CNA thermographer just months before the fire happened.

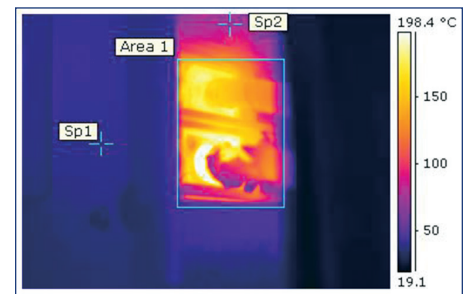
Figure 3. IR image showing a critical thermal fault on an electrical conductor at a fruit processing plant.

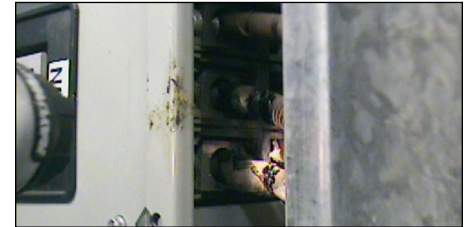
Figure 4. Comparison visual image shows charring of the conductor insulation in the area of the thermal fault.
