Network hub failure

Application Note

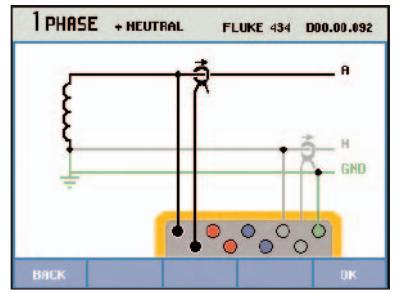
Fig. 1 View configuration screen

After connecting his Fluke 434 to the branch circuit supplying the hub equipment, he checked the View Config screen (Fig. 1) diagram to verify proper connections. From there, he pushed the Scope button and saw an abnormally high neutral waveform. (Fig. 2) He checked the numeric values at the top of the screen and saw that neutral voltage was in fact incredibly high, at 23 volts, indicating a possible neutral-ground issue. He saved that screen for customer documentation.

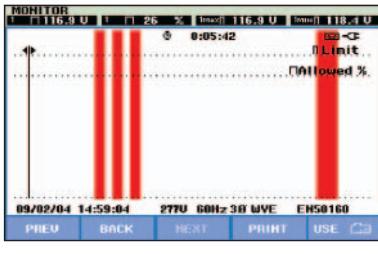
Fig. 4 Set recording time

He pressed the Monitor button (Fig. 4) and set the recording time for 24 hours. After the first 15 minutes, he pushed the trend button while continuing to record in the background. (Fig. 5) Shortly into the cycle he saw a dip in the line. To learn more, he pushed the event table button, checked the numeric values, and saw distinct voltage sags on the branch circuit. (Fig. 6)

The panel was clearly carrying too much load, most likely from one or more of the facility's large motors. That meant the hub was seeing high voltage from the grounding problem and low voltage from the sags, both of which were causing the hub to go down.
