# UK Marine Case Studies

# Case Study 1 – 6.6kV Diesel-Driven Generator

# Case Study 2 – 690V Diesel-Driven Generator

## Case Study 3 – 690V Thruster Motor

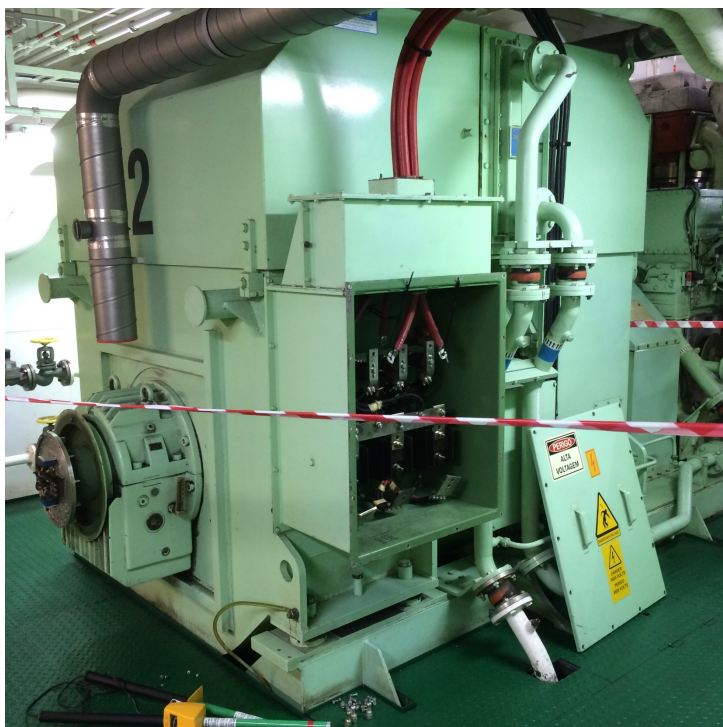
The 3 phase exciter rotor windings failed during the megohm test.

Results Summary		Test Date/Time 22/03/2016 16:38:27	
Test ID: Tested By Room # Location Memo	3 PH Res & Meg Exciter  Seven Oceans  3 Phase Exciter Winding 2	Repair/Job # Tested For MCC Building	Port Engine Room
Temp Status	Tested	PI Status	No Test Performed
Temp	28.0°C 82.4°F	Volts (V)	
IR Temp Compensation	Thermoplastic	DA Ratio	
Resist Status	PASS	PI Ratio	
L1-L2 (Ohms)	0.0626 Corr: 0.0607	HiPot	No Test Performed
L2-L3 (Ohms)	0.0632 Corr: 0.0613	Volts (V)	
L3-L1 (Ohms)	0.0632 Corr: 0.0613	I(μA)	
Max Delta R %	0.899	Resist (Mohm)	
Coil 1 (Ohms)	0.0313 Corr: 0.0304	Surge Status	No Test Performed
Coil 2 (Ohms)	0.0313 Corr: 0.0304	Peak Volt(V) L1	
Coil 3 (Ohms)	0.0319 Corr: 0.0309	Peak Volt(V) L2	
Megohm Status	OVER CURRENT	Peak Volt(V) L3	
Volts (V)	390	Max P-P EAR(%)	No Test
I(μA)	75.5	EAR 1-2/2-3/3-1(%)	--/--/--
Resist (Mohm)	5

Customer asked his motor rewinder to verify our results, as he was on-board performing other work. He confirmed result, and decision was made to strip the machine there and then.

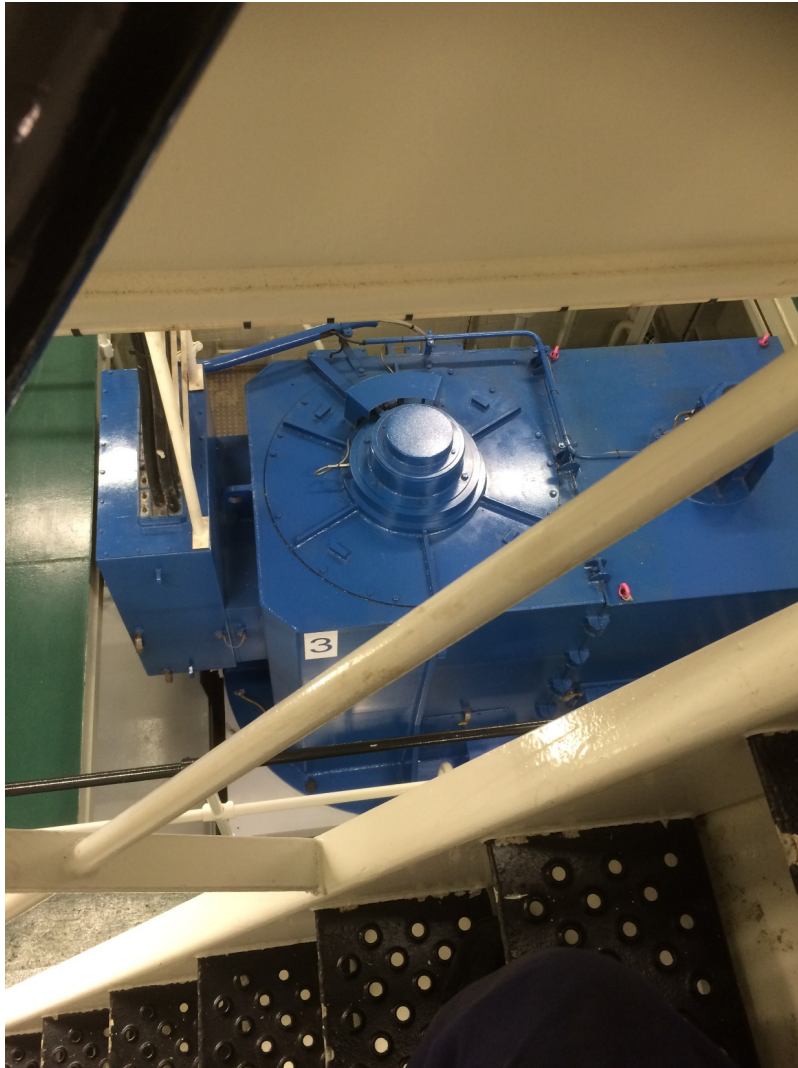
Thruster motors are crucial to pipe laying ships as they help maintain very accurate positioning of the vessel as pipes are being laid, via the GPS dynamic positioning system.

If a thruster motor suddenly trips, position may be lost, resulting in the pipe line being damaged.

Results Summary		Test Date/Time 25/03/2016 17:54:04	
Test ID: Tested By Room # Location Memo	660v Thruster  Seven Waves  Failed first megohm test. Checked connections with same results.	Repair/Job # Tested For MCC Building	Aft Thrusters
Temp Status	Tested		
Temp IR Temp Compensation	23.1°C 73.6°F Thermoplastic	PI Status Volts (V) DA Ratio PI Ratio	No Test Performed
Resist Status	PASS	HiPot Volts (V) I(μA) Resist (Mohm)	No Test Performed
L1-L2 (Ohms) L2-L3 (Ohms) L3-L1 (Ohms) Max Delta R % Coil 1 (Ohms) Coil 2 (Ohms) Coil 3 (Ohms)	0.00173 Corr: 0.00171 0.00174 Corr: 0.00172 0.00175 Corr: 0.00173 0.791 0.00087 Corr: 0.00086 0.00086 Corr: 0.00085 0.00088 Corr: 0.00087	Surge Status Peak Volt(V) L1 Peak Volt(V) L2 Peak Volt(V) L3 Max P-P EAR(%) EAR 1-2/2-3/3-1(%)	No Test Performed
Megohm Status	MIN MEGOHM		
Volts (V) I(μA) Resist (Mohm)	510 5.900 86; 26 At 40°C		No Test No Test

IR of 7.6 GΩ @ 40° C, confirming that the motor is ok, and the likely cause of the low reading are the power cables.

Earthing straps were badly installed and caused chaffing to the cable insulation.

Customer claimed a warranty repair on the shipyard, as the vessel was only 18 months old.
