Overheated transformer

Application Note

Power Quality Case Study

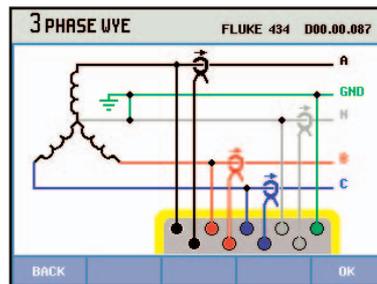
To verify the accuracy of his connections, the technician checked the View Config screen on the power quality analyzer. The one-line diagram matched up.

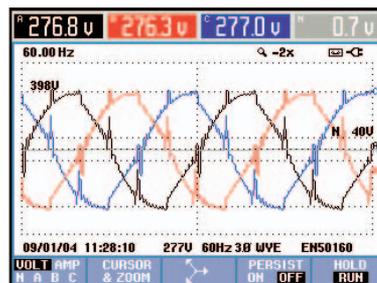
As a starting point, the technician pushed the Scope button, to check for distortion. The waveform signatures were in fact suspiciously distorted.

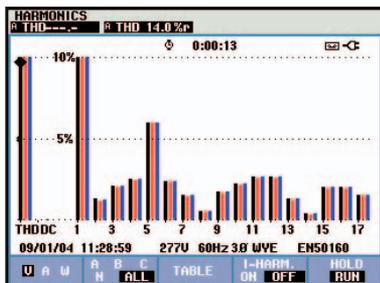
HARMONICS TABLE

The technician selected the Harmonics function from the power quality analyzer menu and reviewed the Total Harmonic Distortion (THD) bar-graph. THD measures the combined action of all the harmonics (on multiple frequencies) present, compared to the overall system. THD should not exceed 5 %.

Volt	A	B	C	T
THD%	14.0	13.5	13.9	77.3
H3%	2.1	2.1	2.1	11.0
H5%	6.0	6.0	6.0	9.2
H7%	1.5	1.5	1.5	1.9
H9%	1.8	1.7	1.8	12.0
H11%	2.7	2.6	2.7	5.1
H13%	1.3	1.3	1.3	2.2
H15%	2.0	2.0	2.0	14.7

At an average of 13.8 % across all phases, this THD reading was way too high. He selected the Watts reading (W) to get an idea of what the K factor was for the transformer’s derating.

Based on the harmonic levels and loading figures gathered by power quality analyzer, the technician went to the floor manager and recommended a new K-rated transformer designed to support the real load for that production area.

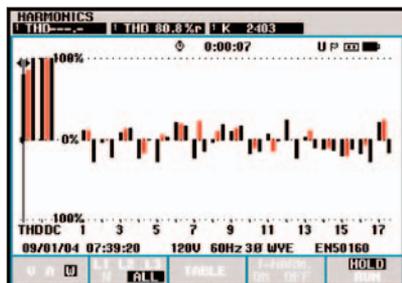
K-factor measures the heating effects of harmonics on transformer loading and losses. K-1 is the baseline for a standard transformer. K-4 would be for times the “normal” heating. K-rated transformer are specifically designed to handle harmonics.

Derating is a way of calculating the realistic load a transformer can carry when harmonics are present. For example, while a transformer may be rated at 150 kVA, harmonics would derate it to a 75 kVA load availability.

The higher the harmonics the less efficient the transformer is and the less current it can carry – the harmonics are competing for the total rating. In this case, the combination of customer load and harmonics had resulted in an overloaded transformer.

In the meantime, he suggested either transferring some of the current load to other transformers or staggering the timing of the loads. He also recommended regular harmonics and system impedance measurements. The new transformer wouldn’t overheat, but given the amount of harmonics on this system they would have to consistently track THD throughout the floor.
