### Important Safety Notice regarding Fluke 8x V Series Digital Multi-meters

Fluke Corporation has identified a potential safety issue affecting certain Fluke 83V, 87V and 88V Digital Multi-meters ('Fluke 8x V series DMMs').

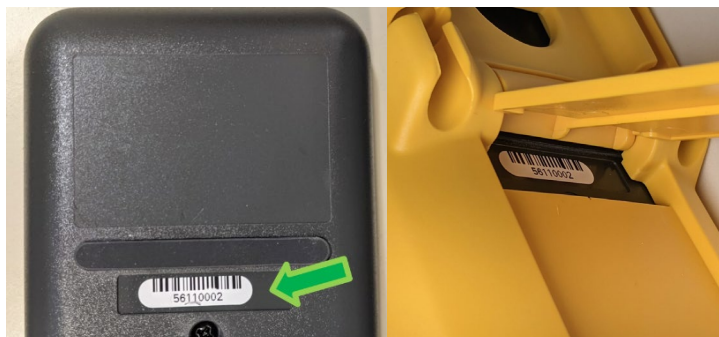
## A. Identify your product serial number

If you cannot locate the serial number on your Fluke 8x V series DMM, or if the serial number is illegible, please follow the actions indicated in this Safety Notice in paragraphs B and C below.

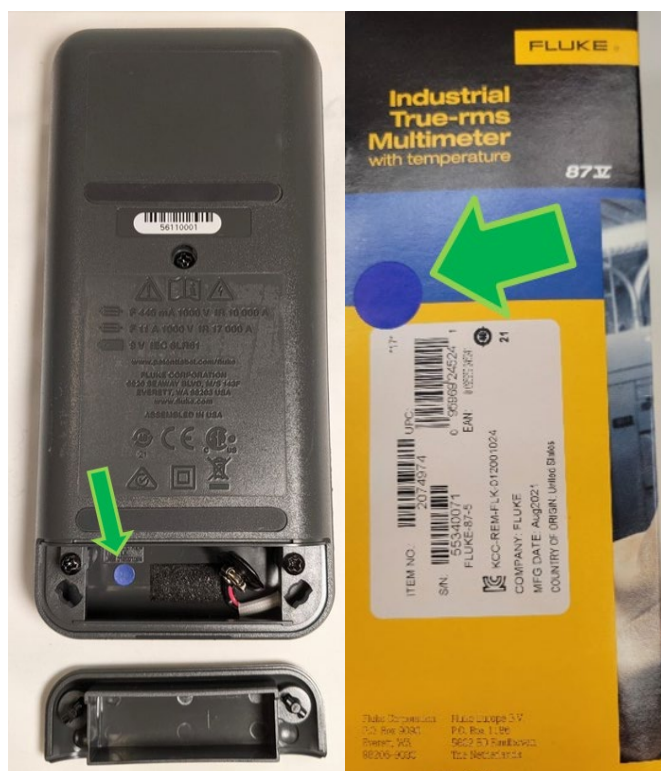
**Units in the defined serial number range that had the issue corrected prior to shipment or through service can be identified by a blue or green sticker in the battery compartment and on the unit packaging:**
